Inspection Report

3455 Anywhere Dr.
Someplace, Ohio 44XXX

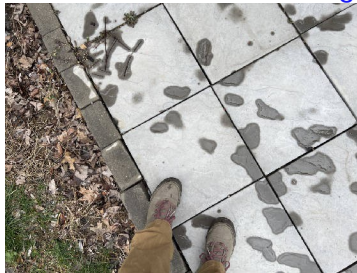
1. Acceptable Driveway: Concrete
2. Acceptable, Marginal Walks: Concrete, Pavers/Stone - **Loose pavers/stone, Recommend maintenance/securing**

1. Walks: Concrete, Pavers/Stone - Loose pavers/stone, Recommend maintenance/securing
2. Grading: Flat and/or negative slope - **Flat or improper soil slope towards foundation is conducive to water intrusion. An expert in grading and drainage will be needed to inspect and improve grading/drainage away from foundation to minimize the possibility of water intrusion. This would also apply to driveways and downspouts adjacent to foundation. At time of occupancy, client should walk around the home while it is raining to see how the water is being diverted away from structure and take action/make improvements/have qualified professional further inspect as needed to prevent any water intrusion.**

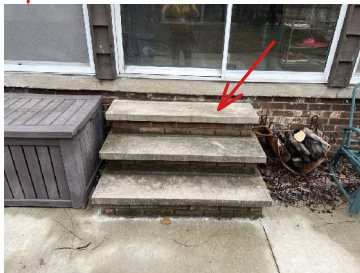
3. Safety Concern Steps/Stoops: Masonry - **Platform/landing not present at exterior side of the door- There should be a landing on either side of an entry/exit door that is at least the width of the door and 36 inches deep "in the direction of travel. Consult with a qualified contractor to further evaluate and provide repair options/estimates that meet minimum safety standards.**

1. Steps/Stoops: Masonry - Platform/landing not present at exterior side of the door- There should be a landing on either side of an entry/exit door that is at least the width of the door and 36 inches deep "in the direction of travel. Consult with a qualified contractor to further evaluate and provide repair options/estimates that meet minimum safety standards.
2. Handrails/Guardrails Missing hand/safety rails, Install hand/safety rails

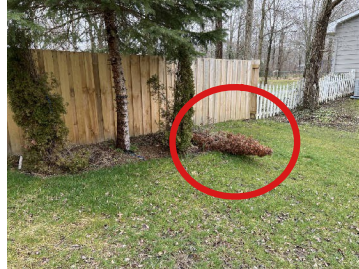
8. Acceptable, Marginal Vegetation: Trees, Shrubs - [Downed vegetation, Recommend removal](#)

3. Vegetation: Trees, Shrubs - Downed vegetation, Recommend removal
4. Exterior Electric Outlets: 120 VAC GFCI - Loose outlet(s), Recommend securing
5. Additional observations/comments: Recommend not storing wood near house/structure-conducive to wood destroying insects

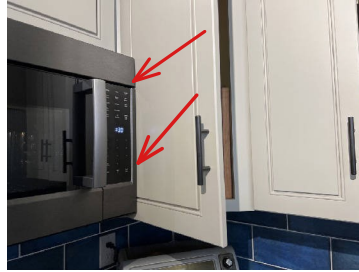
11. Acceptable, Marginal Cabinets: Wood/laminate - Cabinet door does not open entirely & is obstructed by microwave, Recommend remedy/repair

- 12. 1st Floor Kitchen Refrigerator: Operating - Did not dispense ice and/or water from door, Further evaluation and remedy recommended
- 13. 1st Floor Kitchen Cabinets: Wood/laminate - Cabinet door does not open entirely & is obstructed by microwave, Recommend remedy/repair

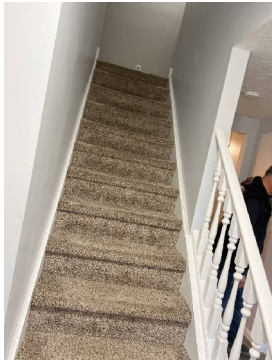
- 7. Acceptable Windows: Fixed, Double hung
- 8. Acceptable Electrical: 120 VAC
- 9. Acceptable Entry Doors: Metal, Sliding, Storm
- 10. Safety Concern Stairs/Handrails: Wood stairs with no handrails - **Missing hand/safety rails, Install hand/safety rails, Hand/safety rail(s) should be graspable and continuous the entire length of the stairway**

3. All rooms other than bathroom(s), bedroom(s), and kitchen(s) are considered the living spaces Living Space Stairs/Handrails: Wood stairs with no handrails - Missing hand/safety rails, Install hand/safety rails, Hand/safety rail(s) should be graspable and continuous the entire length of the stairway

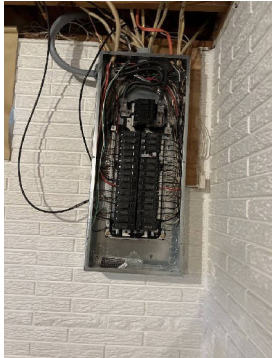
Utility room Electric Panel

5. Acceptable Panel interior(s) Inspected

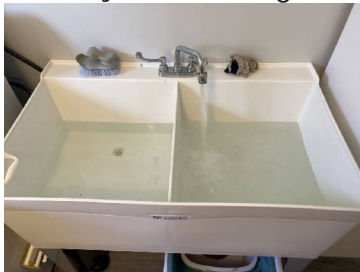
1. Acceptable Ceiling: Drywall
2. Acceptable Walls: Drywall
3. Acceptable Floor: Tile
4. Acceptable Doors: Wood
5. Acceptable Windows: Double hung
6. Acceptable Electrical: 120 VAC GFCI, 240 VAC
7. Acceptable HVAC Source: Air exchange ventilation
8. Acceptable Laundry Tub: Fiberglass

9. Acceptable Laundry Tub Drain: ABS
10. Acceptable Washer Hose Bib: Multi-port
11. Acceptable, Marginal Washer Operated **Laundry room located on 2nd floor. Recommend installing a washer tray with waste pipe attachment in case of overflow, leak, etc.**
12. Acceptable, Marginal Dryer Vent: Metal flex - **Recommend fire resistant smooth walled metal venting**
13. Acceptable Dryer Electric Operated

- 16. 2nd Floor Laundry Room/Area Washer Operated **Laundry room located on 2nd floor. Recommend installing a washer tray with waste pipe attachment in case of overflow, leak, etc.**
- 17. 2nd Floor Laundry Room/Area Dryer Vent: Metal flex - Recommend fire resistant smooth walled metal venting
